THE ELEVATED RAILROAD WRECK IN NEW YORK.

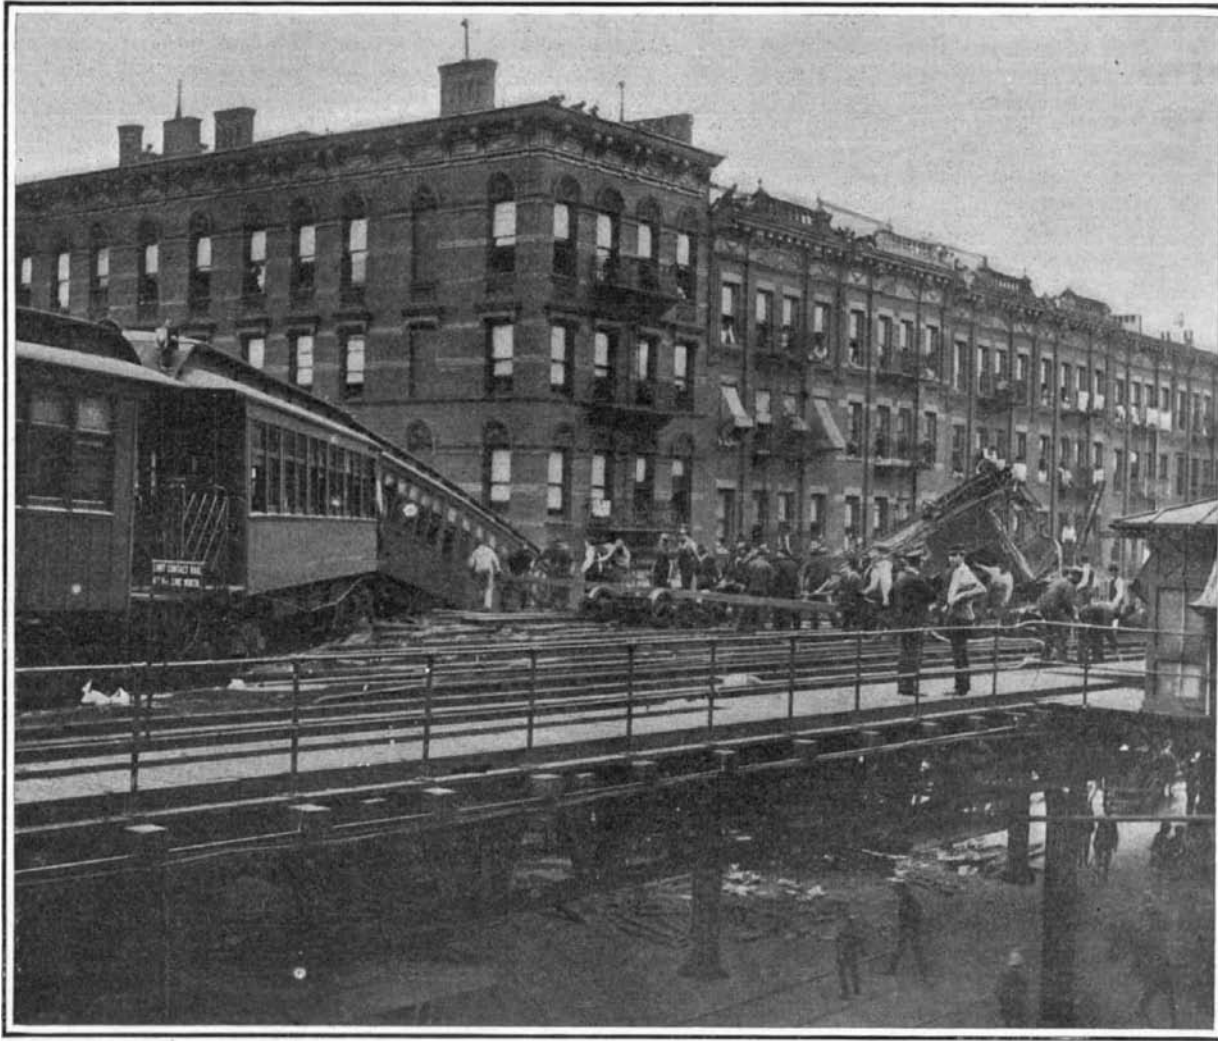
View Looking Southeast, Showing to the Upper End of the Second Car, and the Position of the Third and Following Cars of the Train.

The third car was carried forward by the momentum of the train directly against the northwest corner of the adjacent building, where it came to rest with its front platform about on a level with the fire escape of the second floor of the building, and its rear half resting on the elevated structure, in the position shown in one of our engravings. The people in this car escaped by climbing from the platform to the fire escape, from which they made their way to the street. The other cars to the rear remained on the track and suffered no injury, not even the glass in the windows being broken. This is accounted for by the fact that the

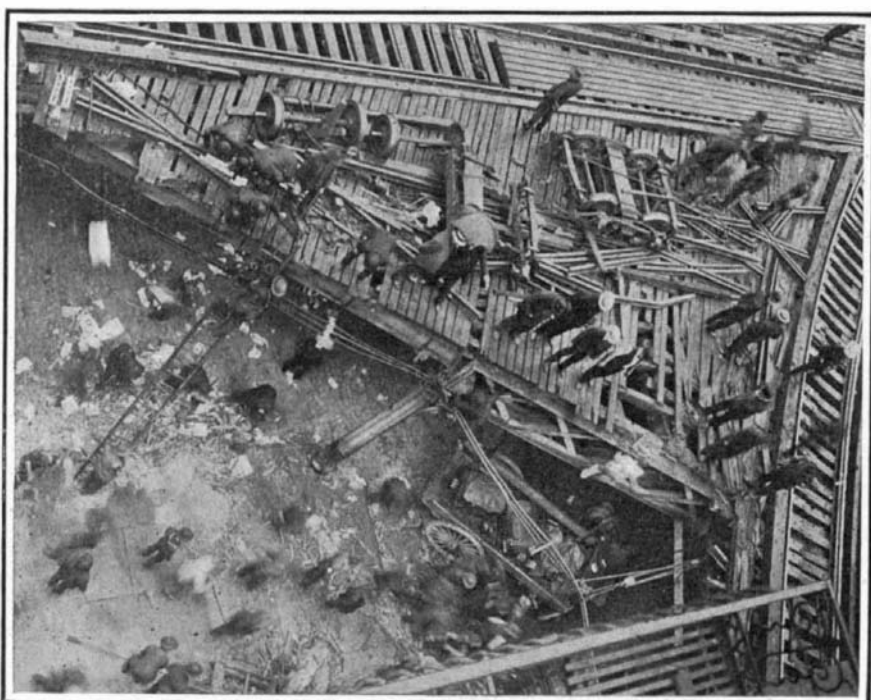
the curve, wrenched loose from the heavy motor car ahead, breaking the couplings, drove ahead diagonally across the Ninth Avenue tracks, swung completely around, and fell over onto the sidewalk below. As it fell, the car rolled completely over so that it struck roof down, one end of the car resting on its roof on the elevated structure, and the lower end resting upon the crumpled-up wreck of the roof and the front of the car, on the street below. The car, and in fact

View Showing the Ninth Avenue Uptown Track, the Curve of the Downtown Track Leading to 53d Street, and the Sidewalk upon Which the Second Car of the Train Landed.

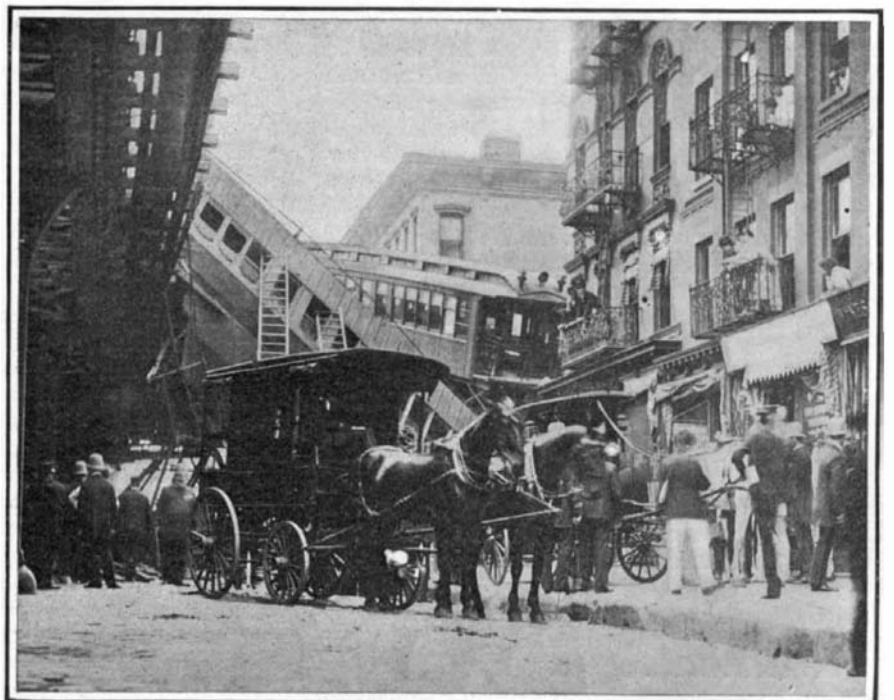
When the second car turned over and fell to the street the upper structure, such as the roofs and sides, was completely wrecked, the roof being practically opened out its entire length. The car was one of the lighter pattern built when the elevated was a steam railroad; and although it was amply strong to resist the stresses of ordinary operation, it proved to be an utter death trap when exposed to the rough handling of this derailment. Herein we find another argument for the rapid introduction of all-steel cars. Had this second car been of the same type as the heavy steel motor cars of the Subway, it would probably have kept the track, or, if it had been derailed and thrown to the street, it would have maintained its form sufficiently to have prevented much of the terrible loss of life. It has been proved over and over again that all-steel freight cars will pass through a derailment or a col-

The Overturned Car is Shown with One End on the Viaduct and the Other on the Street. The Second Car of the Train is Resting Half on the Viaduct with Its Front End Against the Building.

lision and retain their shape so that they are easily repaired and put in service again, while the wooden cars in the same collision will be broken up beyond recovery. In the presence of this disaster, we cannot but feel that another urgent call is being made for the rapid substitution of steel for wooden cars in passenger service.
