**THE SUBSIDENCE OF A CONCRETE BUILDING.**

**A REMARKABLE ACCIDENT.**

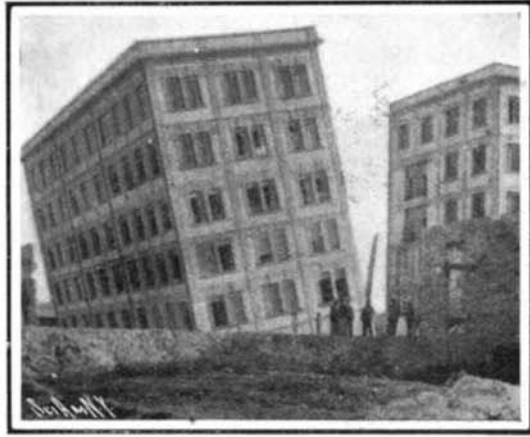
of about 15,000 tons, and this operation was still going on when the theodolite indicated a slight movement on the side farthest from the central structure. The indicated movements were: 7 A. M., 0.79 inch; 2 P. M., 3 inches; 6 P. M., 9.5 feet; 7 P. M., 11.8 feet; 9 P. M., 13.1 feet; midnight, 16 feet.

It appears that the center of gravity, around which as a pivot the building turned, was on a line passing through the center of the block. The efforts of the engineer were accordingly directed toward maintaining this center of movement stationary, and the floor of

Extreme Displacement from the Vertical.

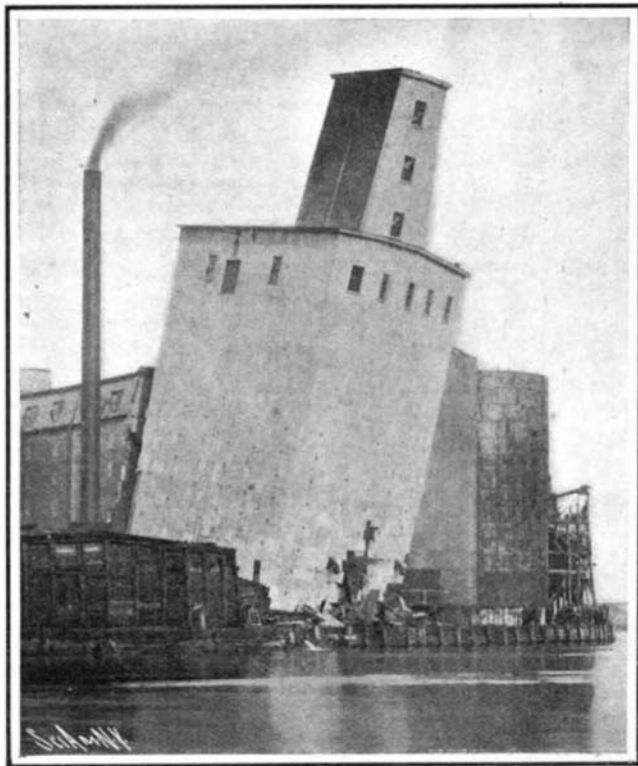
The Grain Elevator After the Impact.

graphs of a strange accident which recently took place at Milwaukee, Wis. One of the elevators of the American Malting Company is located on the bank of the Milwaukee River, upon which considerable heavy traffic is constantly being carried on. A large railroad transfer vessel used for moving loaded railroad cars ran into the bank, owing to a misunderstanding of signals by the engineer. Through this misunderstanding the boat was sent ahead at full speed instead of backing, with the result that it plowed through six or eight feet of piling and con-

crete and thrust the elevator from its foundations, which extended about four feet above the ground. The force of the impact was such that the elevator was shoved into an adjoining brick malt house, and forced about ten feet into the latter building. The tremendous energy with which the vessel crashed into the elevator is clearly to be seen from the condition of the latter as well as that of the malt house. Incredible as it may seem, the transfer vessel was damaged to a slight extent only, the woodwork of the upper part of the bow being shattered for a few feet, while the lower part of the stem was not even dented. This remarkable fact is surely a strong recommendation for the solid construction of the boat, which was probably intended for heavy work in broken ice.
