**THE SUBSIDENCE OF A CONCRETE BUILDING.**

**A REMARKABLE ACCIDENT.**

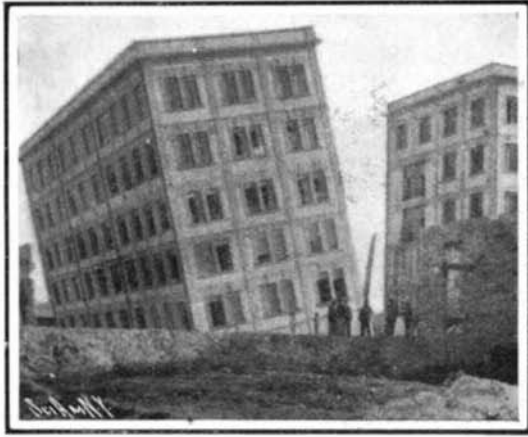
of about 15,000 tons, and this operation was still going on when the theodolite indicated a slight movement on the side farthest from the central structure. The indicated movements were: 7 A. M., 0.79 inch; 2 P. M., 3 inches; 6 P. M., 9.5 feet; 7 P. M., 11.8 feet; 9 P. M., 13.1 feet; midnight, 16 feet.

It appears that the center of gravity, around which as a pivot the building turned, was on a line passing through the center of the block. The efforts of the engineer were accordingly directed toward maintaining this center of movement stationary, and the floor of

Extreme Displacement from the Vertical.

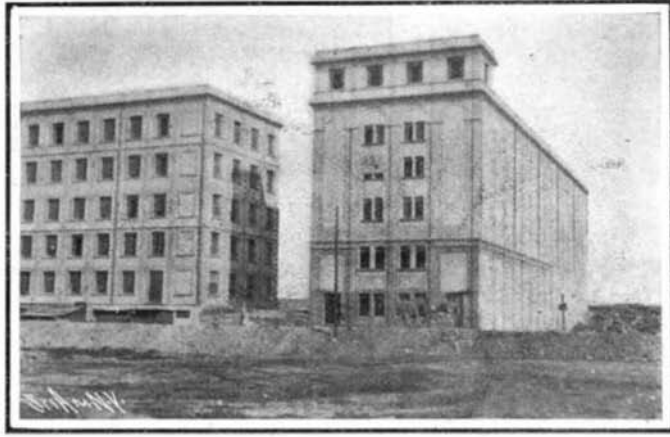
The Structure After Being Raised to Its Normal Position.

This was duly effected in less than a fortnight. The floors on the elevated side of the building were weighted; this counterpoise consisted of some 4,000 tons of sand in bags on each of the ground or underground floors and 2,000 tons on the upper stories. Excavations were also made alongside the foundations on the same side in order to allow the soil to give way more easily.

the building on the upheaved side was elevated about three yards above its normal height. The method adopted in April was again employed in August, and with equal success. The material already in the building was transferred to the elevated side. In the case of both buildings the subsidence has been considerable, for both now stand five to six yards below their intended level. The site is responsible for these accidents, which have been a source of no little expense, delay, and vexation. The ground was, however, declared solid enough by an Italian engineer, whose plans were followed. The displaced and replaced buildings remained uninjured and their parts were undisturbed, a wonderful testimony to the cohesion and tenacity of these concrete structures. The armored concrete construction is now, in consequence, lauded to the skies. There are those however who maintain that in such situations, the better course regardless of expense, would be to adopt the Dutch system of building upon a foundation of piles.

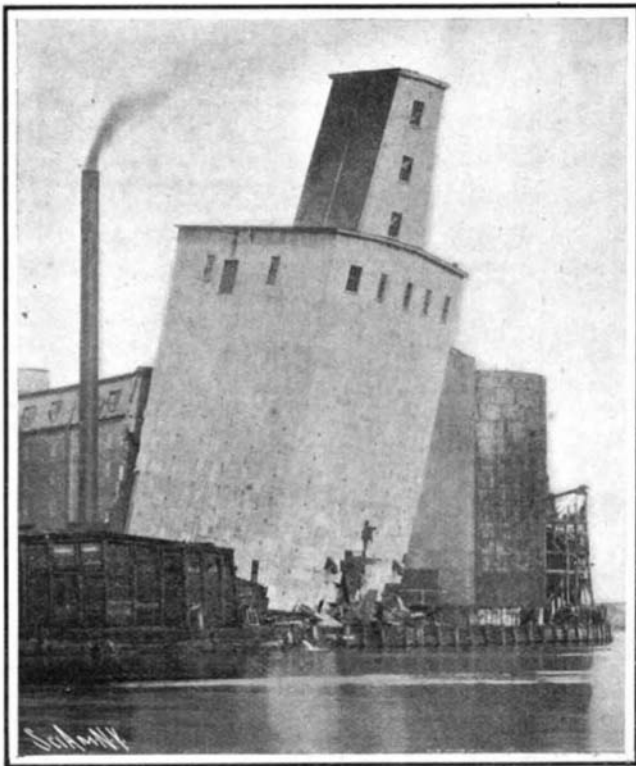
The Grain Elevator After the Impact.

graphs of a strange accident which recently took place at Milwaukee, Wis. One of the elevators of the American Malting Company is located on the bank of the Milwaukee River, upon which considerable heavy traffic is constantly being carried on. A large railroad transfer vessel used for moving loaded railroad cars ran into the bank, owing to a misunderstanding of signals by the engineer. Through this misunderstanding the boat was sent ahead at full speed instead of backing, with the result that it plowed through six or eight feet of piling and con-

crete and thrust the elevator from its foundations, which extended about four feet above the ground. The force of the impact was such that the elevator was shoved into an adjoining brick malt house, and forced about ten feet into the latter building. The tremendous energy with which the vessel crashed into the elevator is clearly to be seen from the condition of the latter as well as that of the malt house. Incredible as it may seem, the transfer vessel was damaged to a slight extent only, the woodwork of the upper part of the bow being shattered for a few feet, while the lower part of the stem was not even dented. This remarkable fact is surely a strong recommendation for the solid construction of the boat, which was probably intended for heavy work in broken ice.

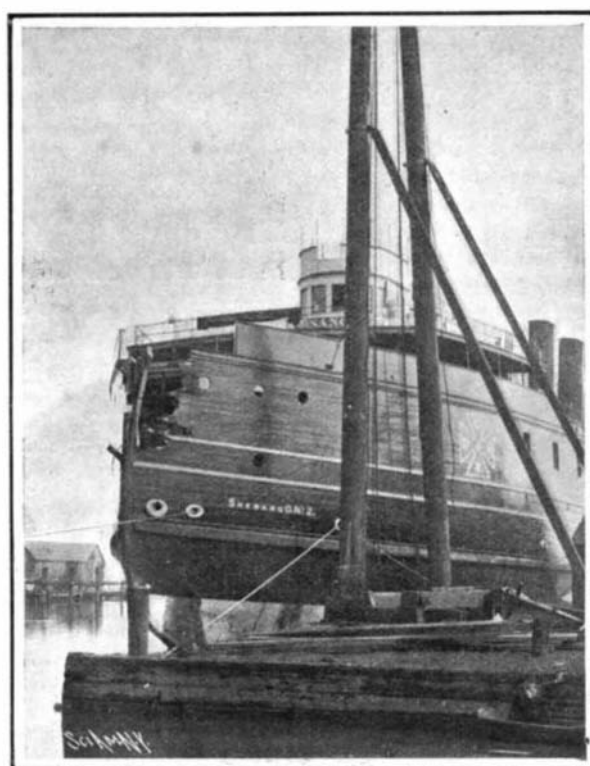
The Transfer Steamer Which Ran Into the Elevator.
